WALL CRACK AND JOINT TREATMENT - PLAN VIEW - HAIRLINE (< 1/16")

SYSTEM NAME	DRAWING NUMBER	<h1>XT5</h1>
	XT5	24.252.1	
	DRAFTER	DATE	
	RJT	09/19/2022

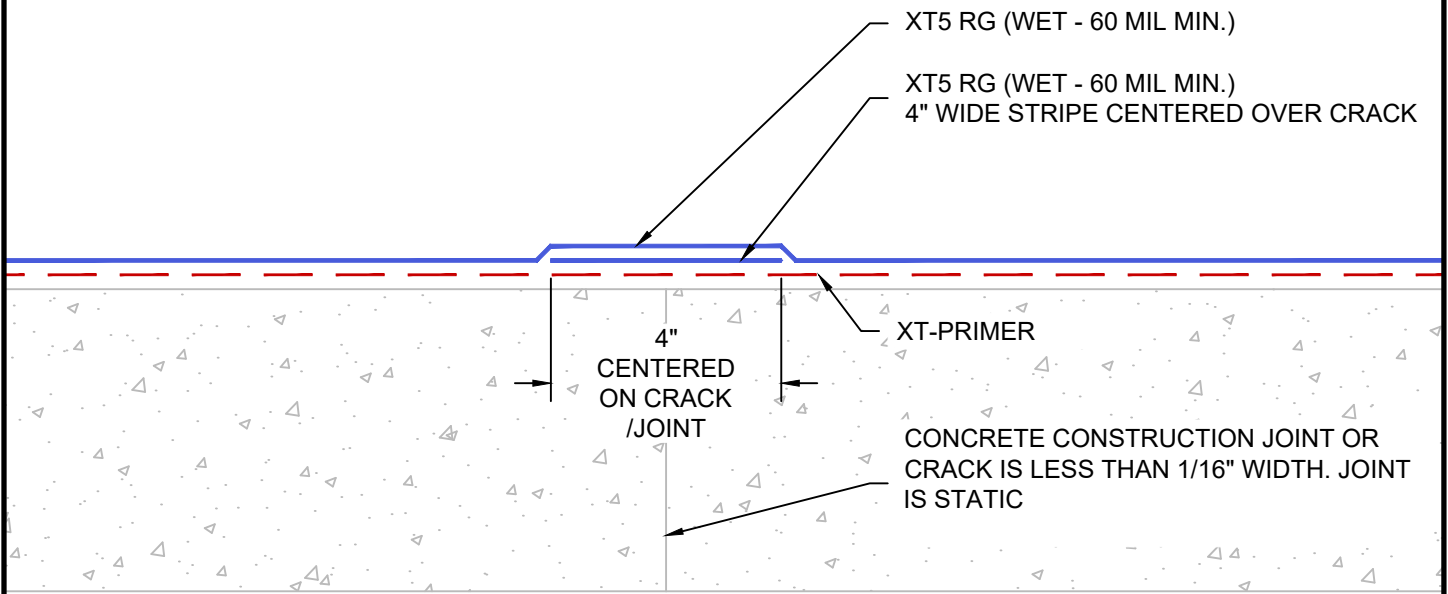
1. XT5 IS NOT RATED FOR LONG TERM UV EXPOSURE AND MUST BE PROTECTED WITH BACKFILL, CONCRETE, OR WITHIN AN ENCLOSED TANK.
2. FOR LONG TERM UV EXPOSURE, SEE XT1.
