**WALL CRACK AND JOINT TREATMENT - PLAN VIEW - STATIC - (1/8" - 1/4")**

| | XT5 | 24.252.3 | |

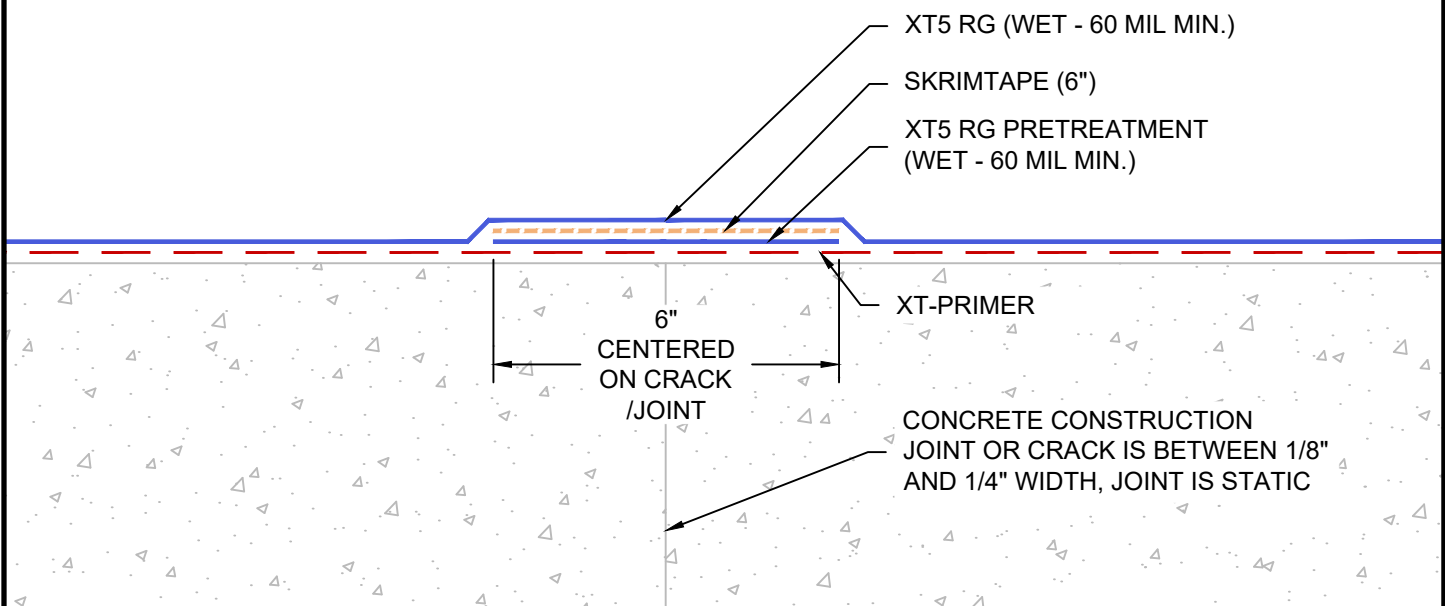
1. CRACKS GREATER THAN 1/4" MUST BE ROUTED OUT AND TREATED LIKE A JOINT.
2. XT5 IS NOT RATED FOR LONG TERM UV EXPOSURE AND MUST BE PROTECTED WITH BACKFILL, CONCRETE, OR WITHIN AN ENCLOSED TANK.
3. FOR LONG TERM UV EXPOSURE, SEE XT1.
