WALL CRACK AND JOINT TREATMENT - PLAN VIEW - EXPANSION CORNER

SYSTEM NAME	DRAWING NUMBER	<h1>XT5</h1>
	XT5	24.252.6	
	DRAFTER	DATE	
	RJT	09/28/2022

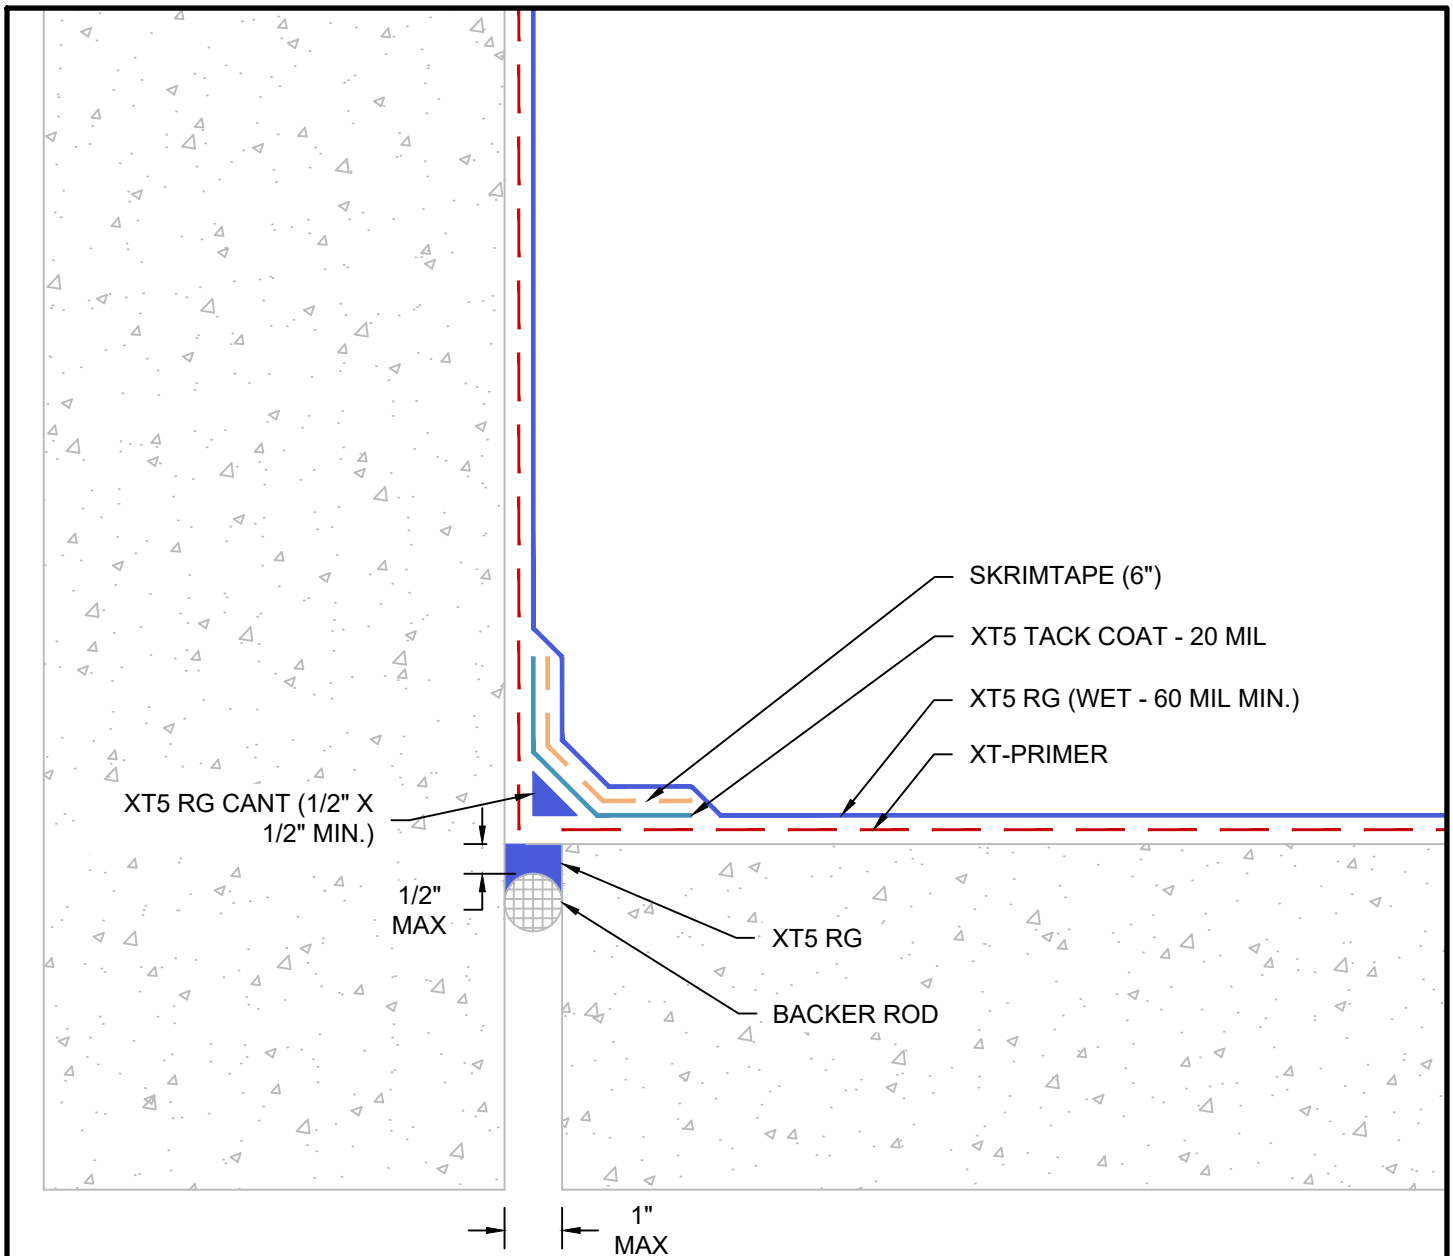
1. JOINT MOVEMENT NO MORE THAN 1/4".
2. XT5 IS NOT RATED FOR LONG TERM UV EXPOSURE, SEE XT1. UV-EXPOSURE AND MUST BE PROTECTED WITH BACKFILL, CONCRETE, OR WITHIN AN ENCLOSED TANK.
3. FOR LONG TERM UV EXPOSURE, SEE XT1.
